Repairing Mercedes W123 Power Window Regulator, Rear

When you remove a power window regulator from your car because it's operating poorly the most frequent issue is that the regulator has bent out of shape from years of stress. In many cases the regulator can be returned to use with some repair.

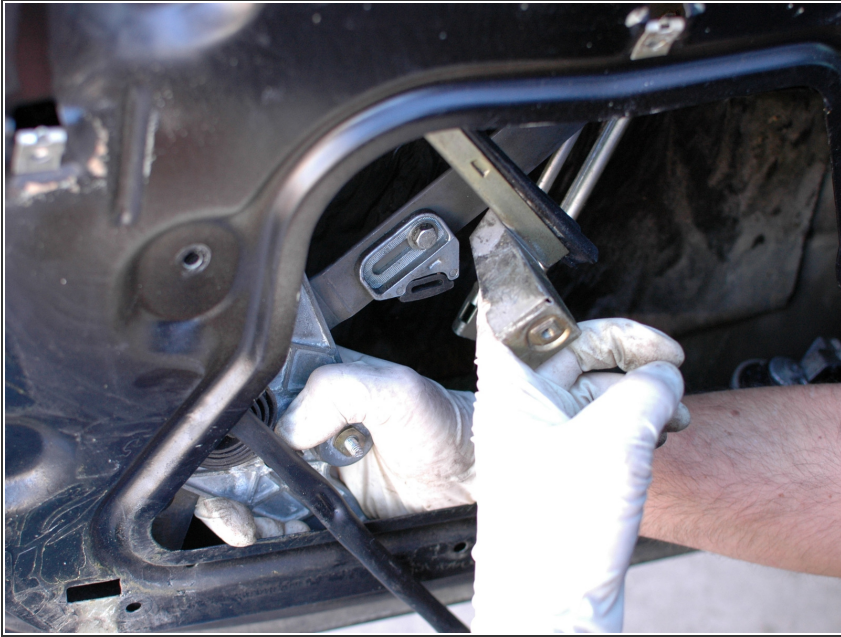
Step 1 — Repairing Mercedes W123 Power Window Regulator, Rear

- Before you can attempt to repair your rear power window regulator it must be removed from the door. [Click here to review the rear power window regulator removal guide.](#)

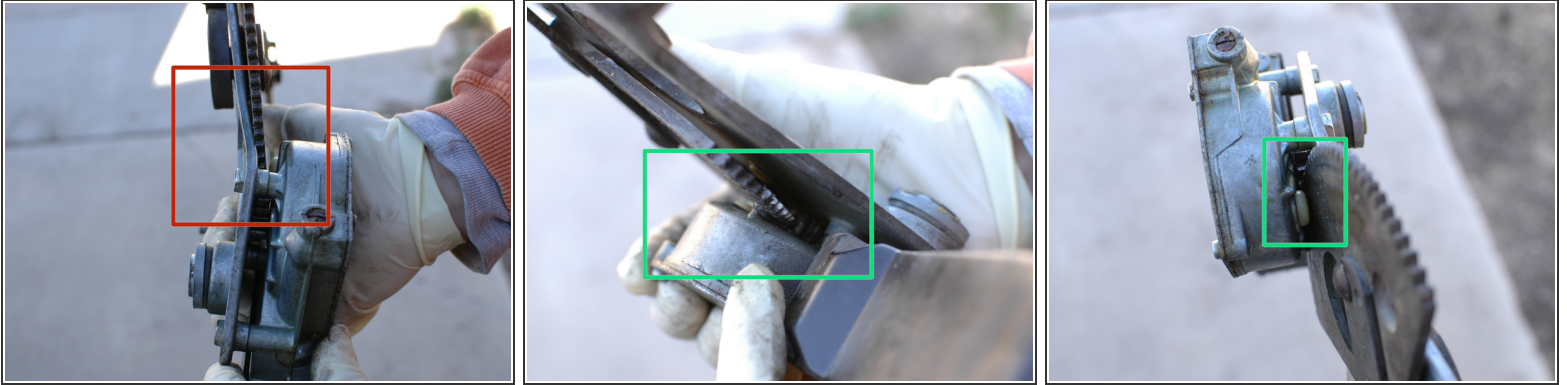
Step 2

- Once removed, inspect the regulator. The primary metal structure of the regulator should be relatively flat/straight. Inspect it for bends. Inspect the teeth on the large regulator gear and on the small motor gear for uneven wear or broken teeth.
- On this particular regulator used in this example you can see it is very obviously bent away from the motor.
- This is causing the large gear to rub against the motor body in two places. This explains the slow movement of the window even after greasing the felt slides on the window rails; the friction of the gear rubbing on the motor housing is stressing the motor.
- The teeth on the gears and motor showed some wear but still appeared serviceable and none of the teeth were broken. If this was not the case the process would need to stop here while a good used regulator was sourced.

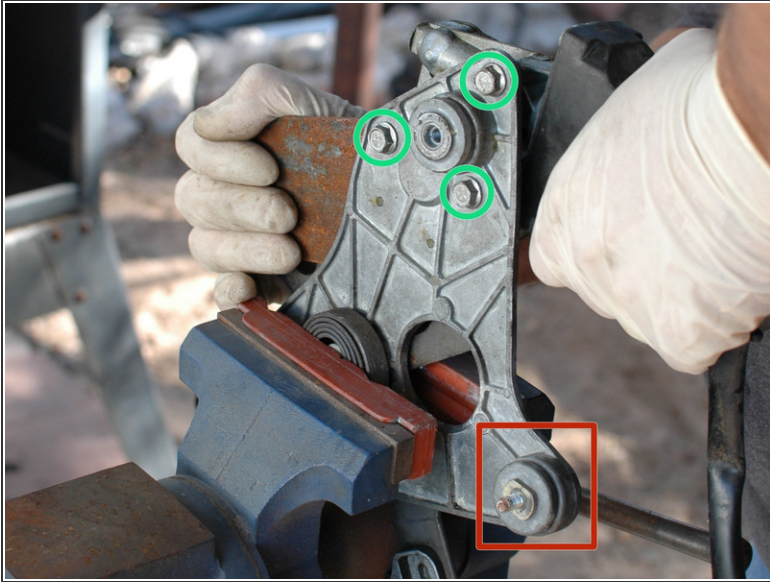
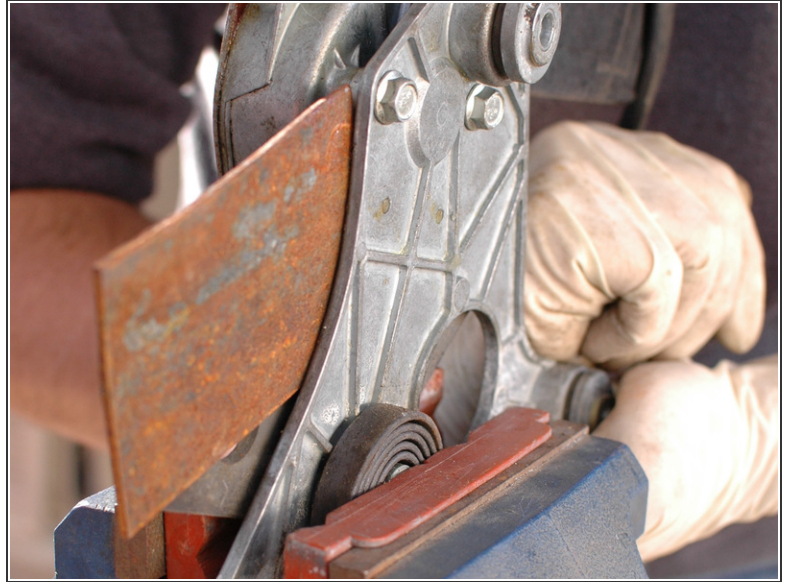
Step 4

- In these pictures you can see that in this case a flat metal piece was used to help pry the regulator body away from the motor at one point. It's just one example of places that the regulator can bend and how it can be returned to its proper position.

- With the regulator properly secured begin bending the regulator in an effort to straighten the main frame. No two regulators bend in just the same way so you will need to bend it with your best judgement.

- The metal of the regulators is fairly soft so it will usually bend without excessive effort. However, be thoughtful about how you bend it especially when bending the ends near the door attachment pegs. If pushed too far the metal of the frame can break at which time you'll need to source a good used regulator.

- If necessary, the motor can be removed from the regulator to allow for that end to be held in the vice or otherwise manipulated. To do so, remove the three bolts holding it to the regulator and pull it away from the frame.

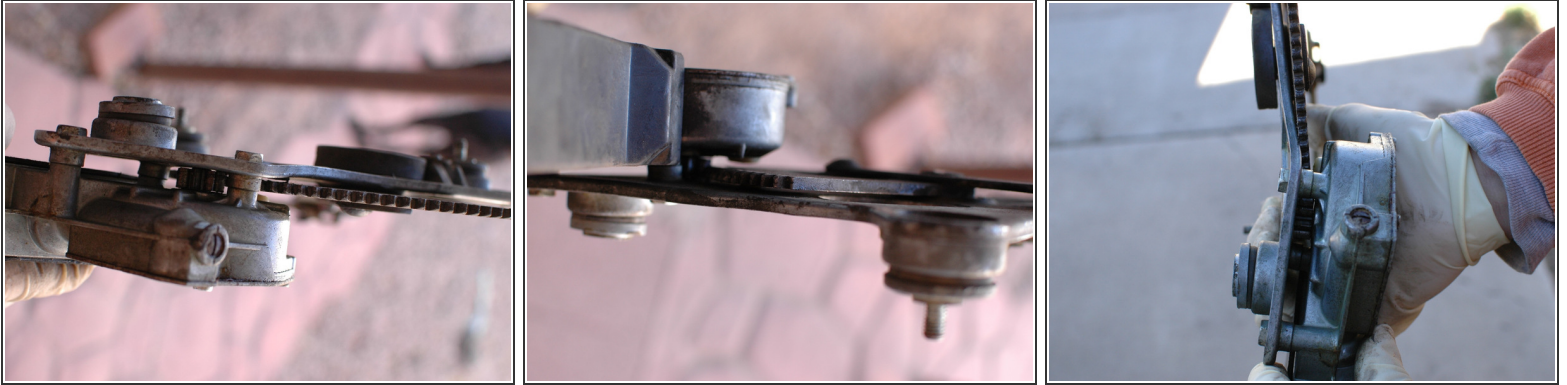
Step 5

- After bending the regulator back you can see that it's much straighter and that the gear now can move freely without rubbing. You can compare it to the original state of the regulator in the third picture.
- Before re-installing the regulator grease the gears thoroughly with an extreme duty grease like moly wheel bearing grease or SuperLube silicone grease.
- After bending and lubricating the regulator on this car was re-installed in the door. The window moves up and down somewhat more quickly, and without any rattling or clunking, but it still moves much more slowly than desired. It is likely that this motor has been damaged by the window being used despite the bent regulator.
- In a future guide the motor will be replaced with a good used motor.

Once you've fixed your regulator it can be re-installed in the door.
